# Installation ISTA-D & ISTA-P with ICOM, K-DCAN & ENET adapters. Errors & their solutions.

# Installation ISTA-D & ISTA-P

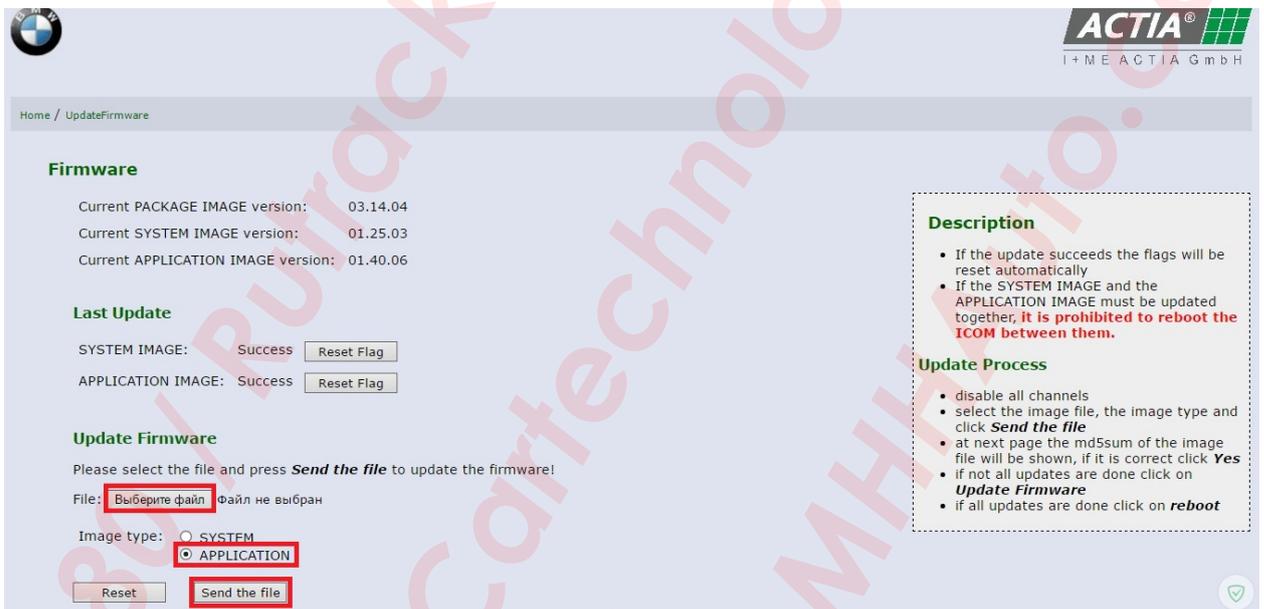
Next, select the update file **ICOM-ApplicationImage-xx-xx-xx.bin**, the latest version at the time of the update, and click **Send the file**.

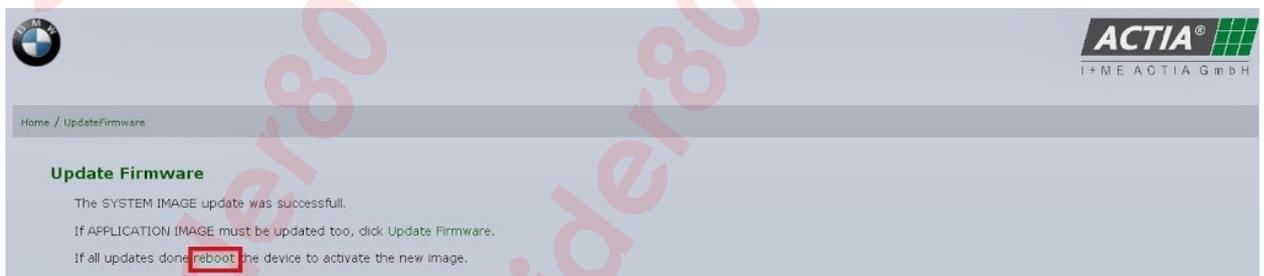
We are waiting for the update. In the next window, click Reboot. After that ICOM should reboot.

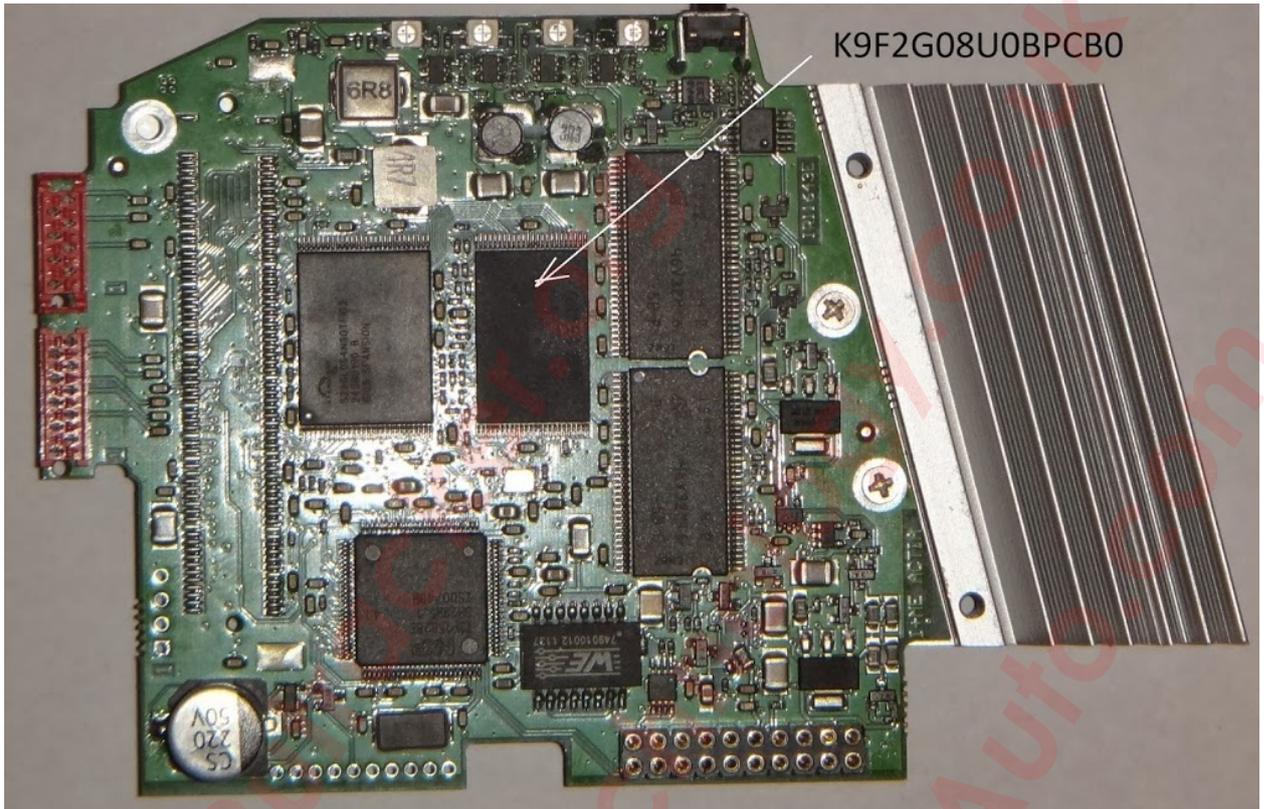
I warn fans to remove the chip, with the ax, nichrome filament, blades, needles, ICOM card in a very delicate and the slightest overheating or attempt to raise the legs lead to the detachment filament tracks. The board under the flash chip a lot of empty dimes, which are easy to fly off even with careful removal flash. This need not be scared as they are empty, and are not connected to other components.

1. Remove flash chip [K9F2G08U0BPCB0](#).
2. Soldering a new one.
3. Restore via USB drive with [ICOM\\_Restore.bin](#).
4. Update the firmware via the web interface.

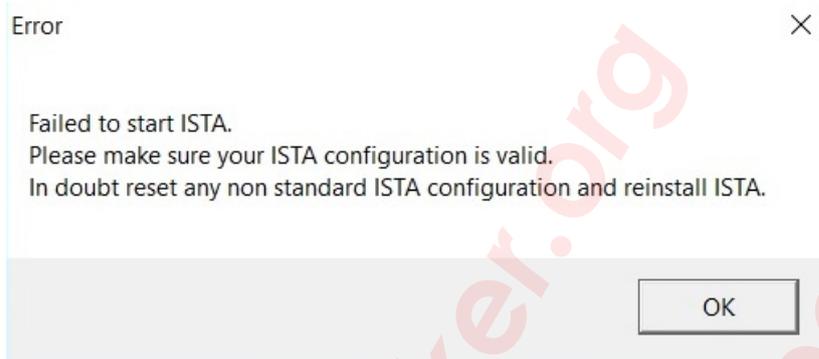
This error have several reasons:

1. Not all vcredist installed. Basically [vcredist 2013 x86](#) and [vcredist 2015 x86](#).
2. Do not [RCleanerV4.4.exe](#) was launched or it is not fully worked. There were traces in the registry from a previous installation.
3. Clean the [hosts](#) file.
4. There is no bases in [SQLiteDBs](#) folder.

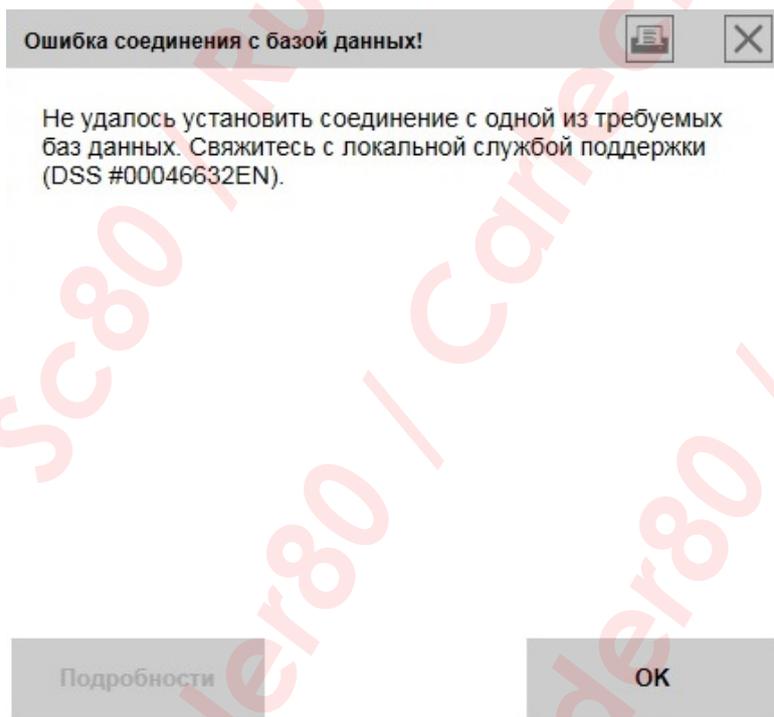
This is perhaps the most common error. When this error, check the contents of the folder [SQLiteDBs](#). Not properly or not fully unpacked base. An example of how it should look like the content is in the chapter [Installation ISTA-D](#). Also, this error occurs when you first start ISTA-D if the above named folder does not contain the base EN, because the default interface language is English. Just change the language setting on yours and, if that database is in a folder, the error no longer appears. On Windows 10, this may be a permission restriction if Rheingold is installed on drive C. Move the Rheingold folder to [C:\users\“user name”](#).

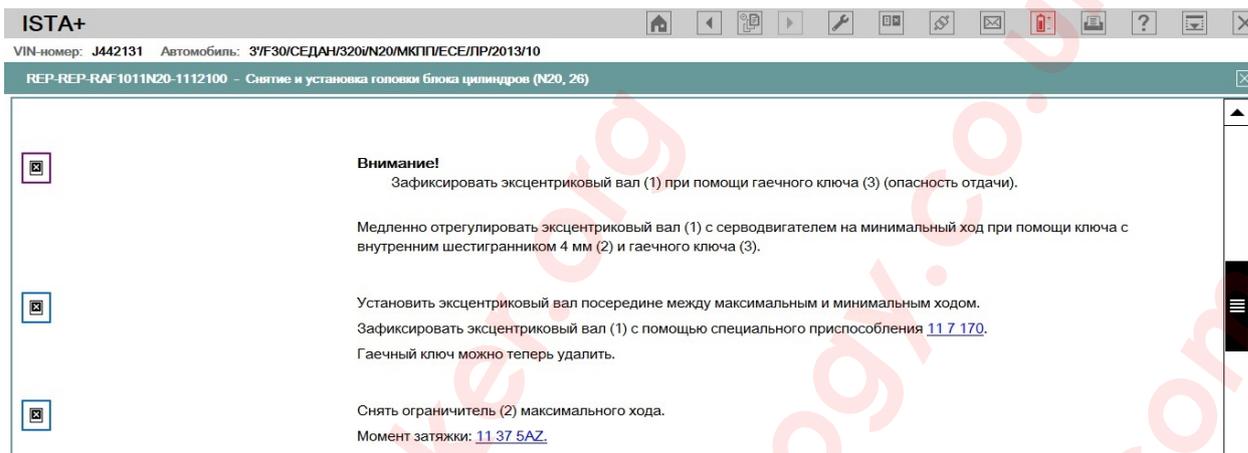
Squares instead of images. The problem with this error in the username folder. When you install Windows, it was necessary to enter a user name in the Latin alphabet. Cyrillic program does not digest. Decisions of the two, or create a second user with the name in Latin, or reinstall Windows.

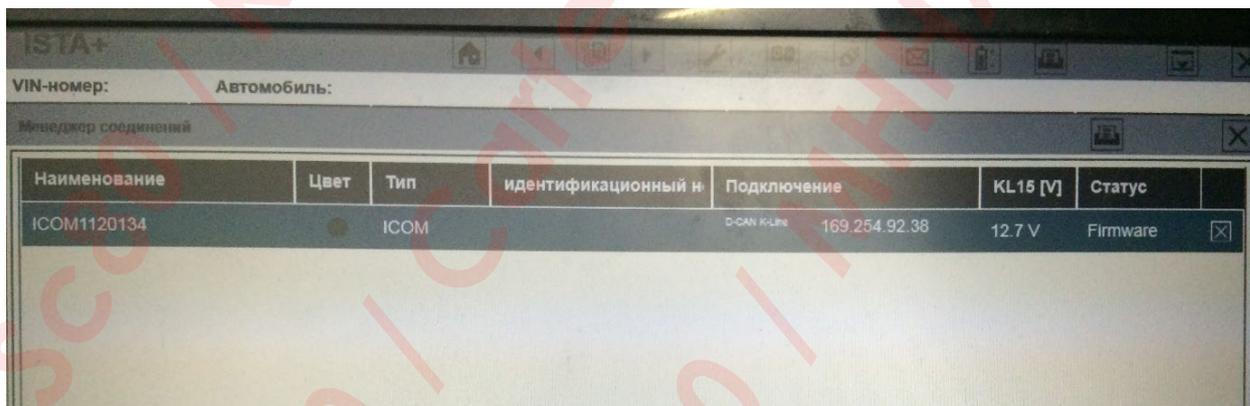
Here ISTA-D requests to update the firmware of ICOM. How do that you can read in the chapter *Firmware update ICOM*.

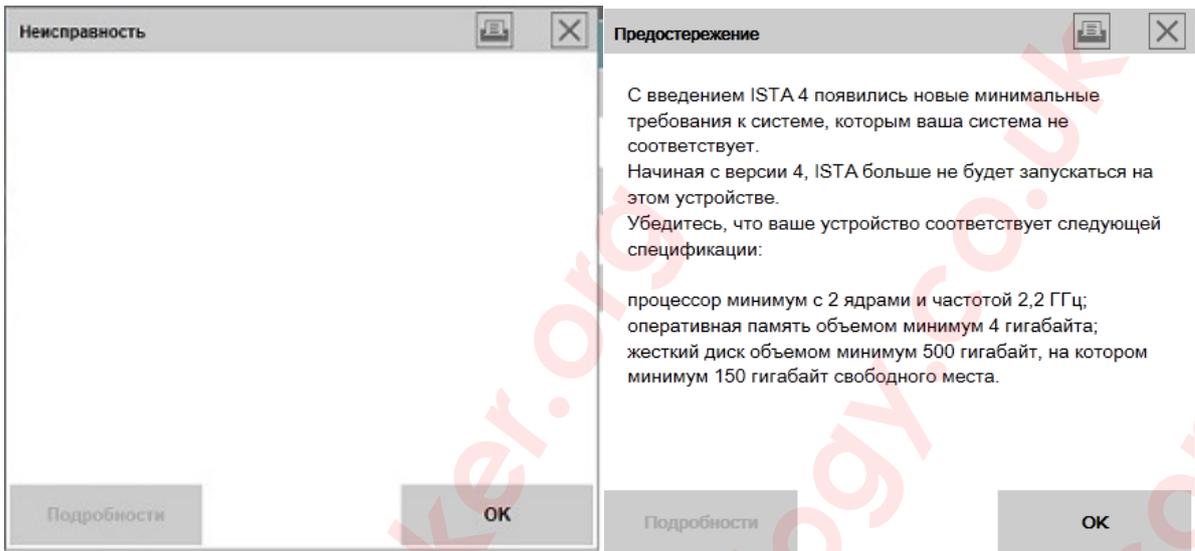
These two faults indicate that your time to a computer in the trash. The one on the left says about the lack of free space on the disk where you installed ISTA-D. It must be 150 or more GB of free space. It can be ignored and click not OK, and X in the upper right corner. The one on the right speaks for itself. Exits two, use a modified ISTA-D, or buy a normal PC.

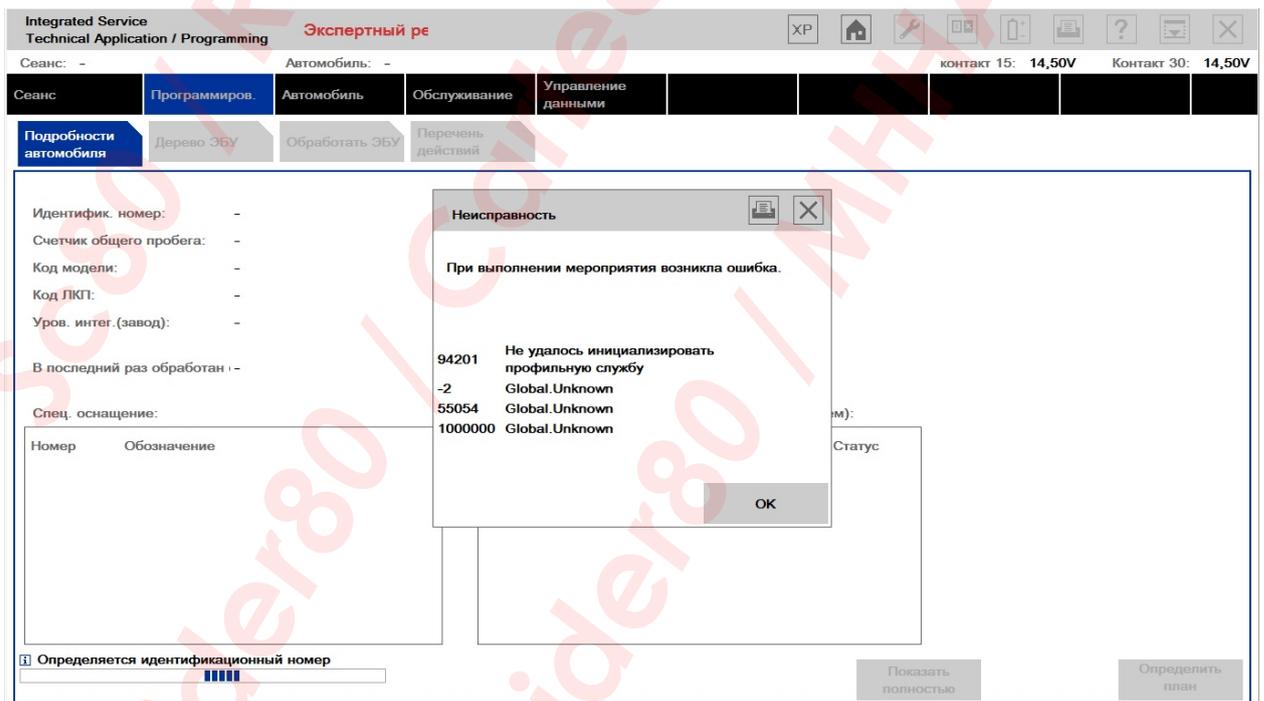
This error indicates that someone has not read the chapter [Setting K-DCAN adapter](#), and incorrectly configured [EDIABAS](#) or [NetworkTool](#). No connection to the adapter. Or your K-DCAN is dead.

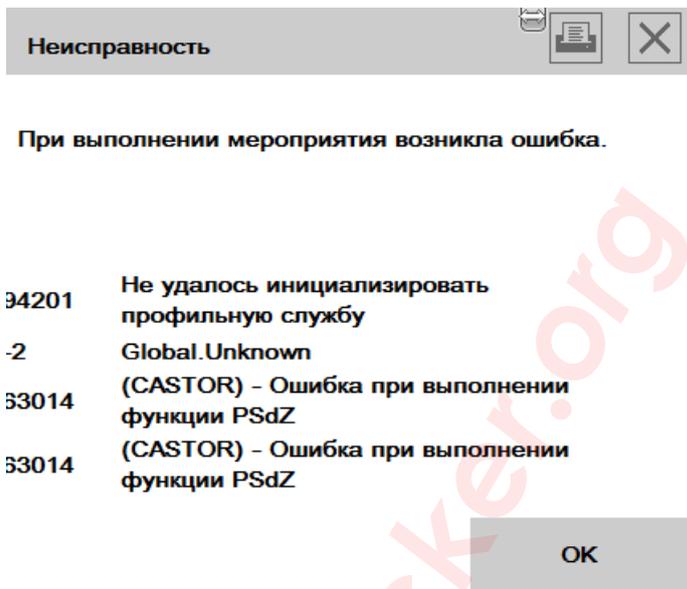
Here you again need to update the firmware ICOM or re unpack ISTA-P with 7-zip.

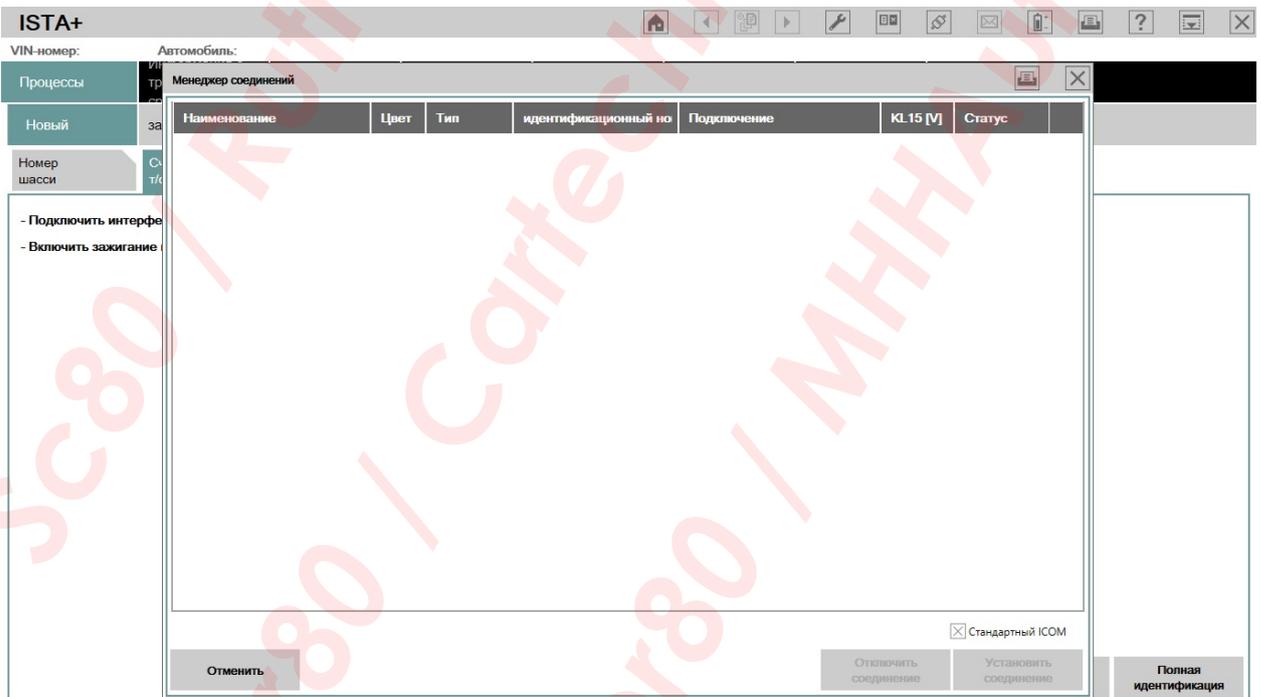
Anyone who sees such a screen when you try to connect to the car, when setting VCI **"HO-ICOM / ENET local network"** through WIFI, the problem lies in your WIFI card driver. Try to roll back the driver to the older version. For example, I have a WIFI card Atheros AR956x. On Win7 and Win10 everything works like clockwork, and Win8.1 refused. The driver was **10.0.0.326**, rolled to **10.0.0.285** and everything worked fine. From the principle I tried to update the driver again, and again everything stopped working. So try to play around with drivers and find a best one.

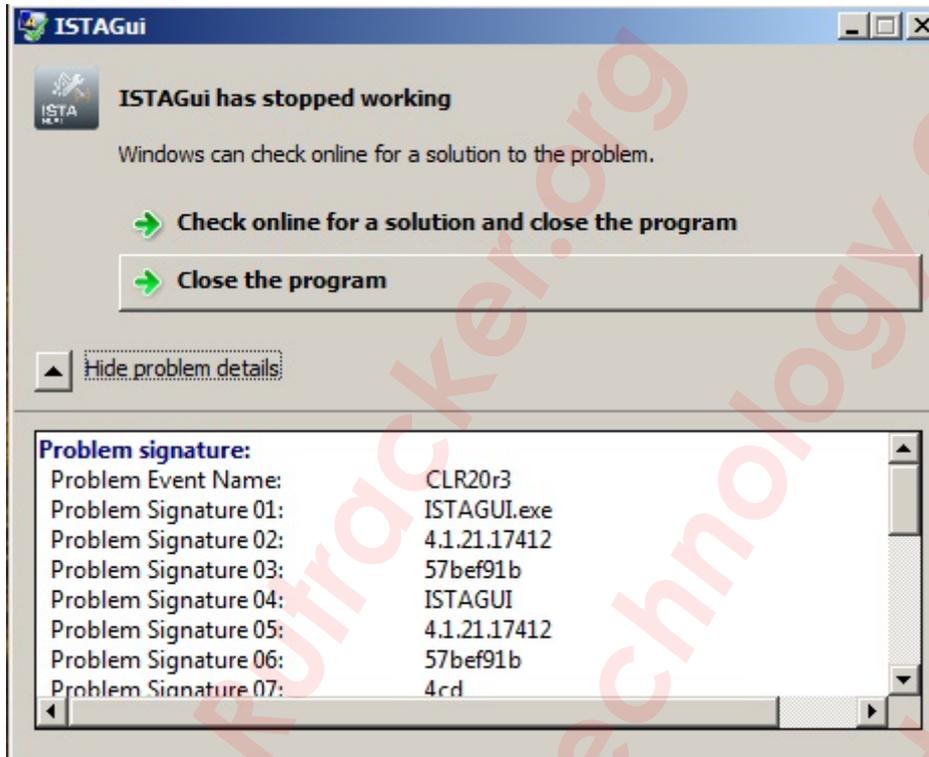
If we see such a window with an error, then it is necessary to update Windows with the latest updates. This usually refers to Windows 7, but is also found on other, non-updated systems.
